**HISTORIC BUILDING ANALYSIS & RECORDING  
LEVEL II**

**9 High Street, Caerleon, Newport**

**Planning Application 26/0208 and associated Listed Building Consent Application**

**Grade II Listed Building Cadw Ref: 2968**

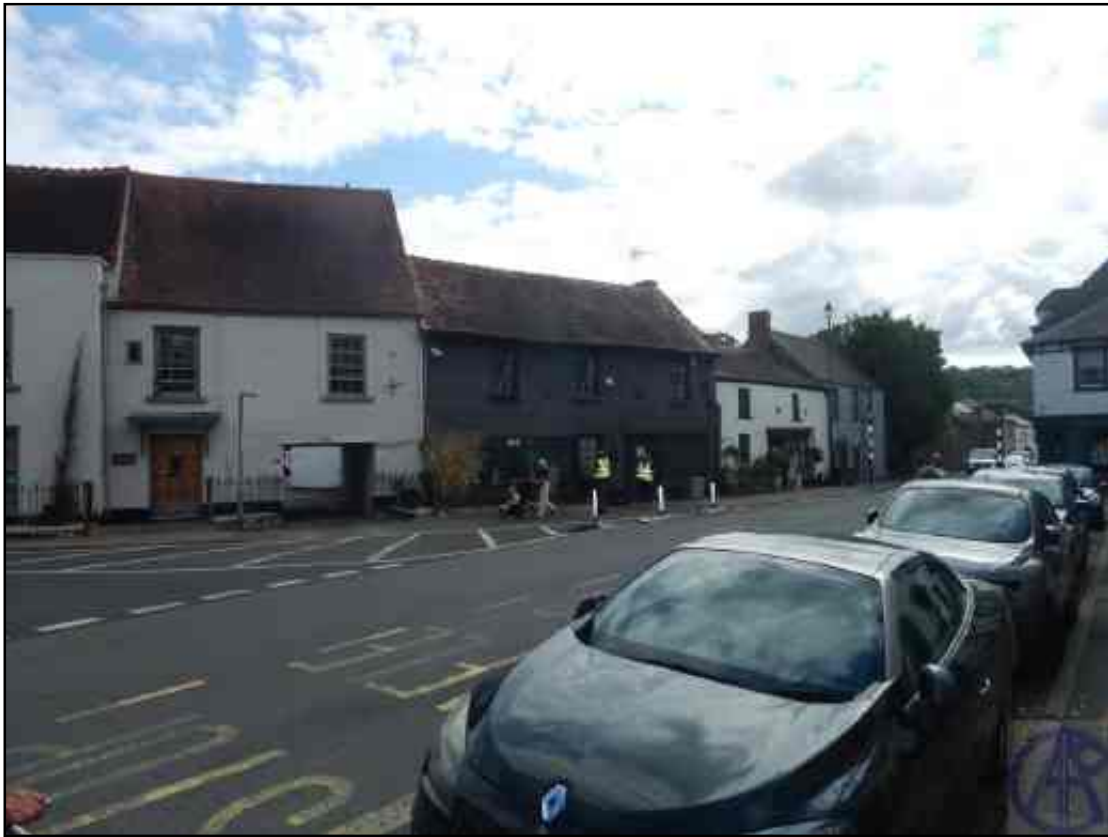
Photo ID: DSCN4383

Junction between No. 9 and the adjoining property at the southern end of the principal elevation.

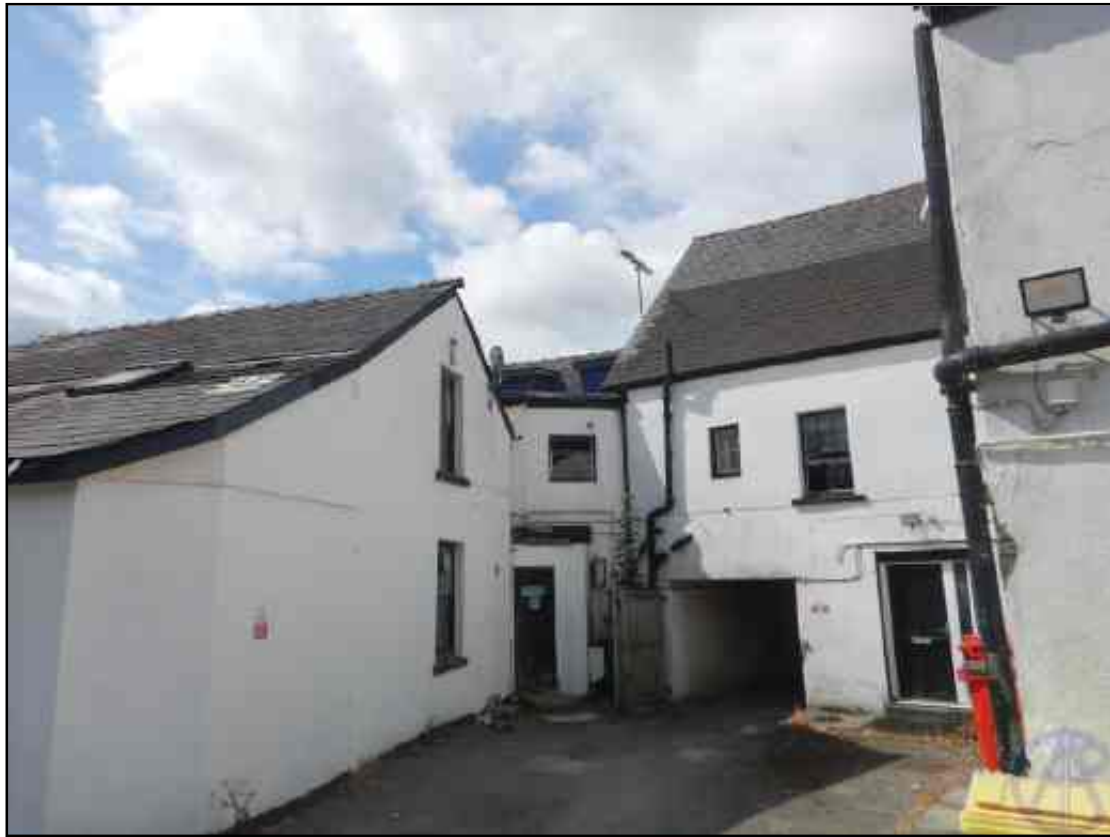
Photo ID: DSCN4371

Broad rendered wall section at the northern junction with the adjoining property.

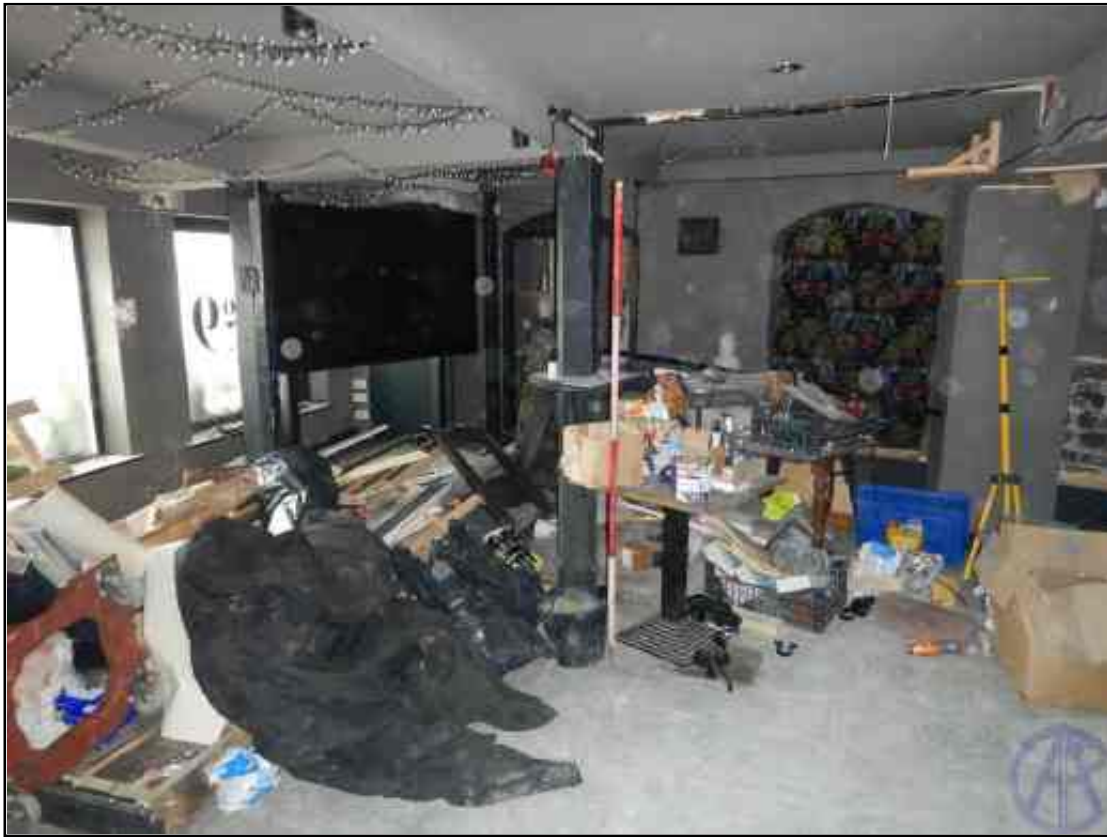
Photo ID: DSCN4393

Arched recesses within the substantial north-western wall of Room 1.

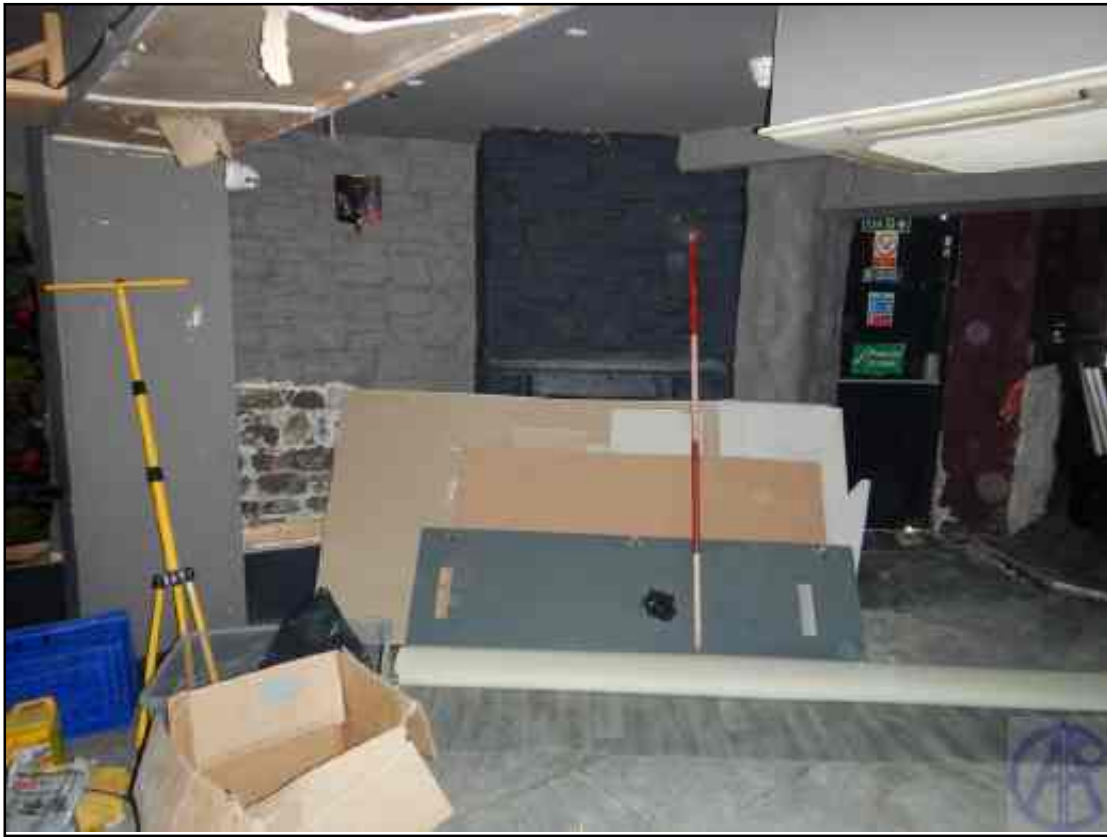
Photo ID: DSCN4399

Angled rubble wall, brick-built fireplace or blocked fireplace and rendered pier in Room 1.

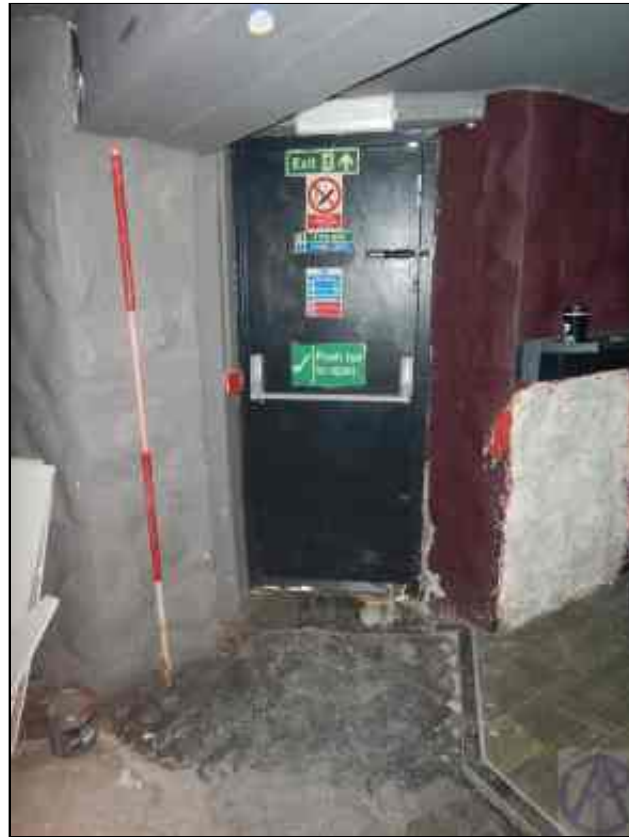
Photo ID: DSCN4401

External doorway positioned at the junction of differently aligned walls in Room 1.

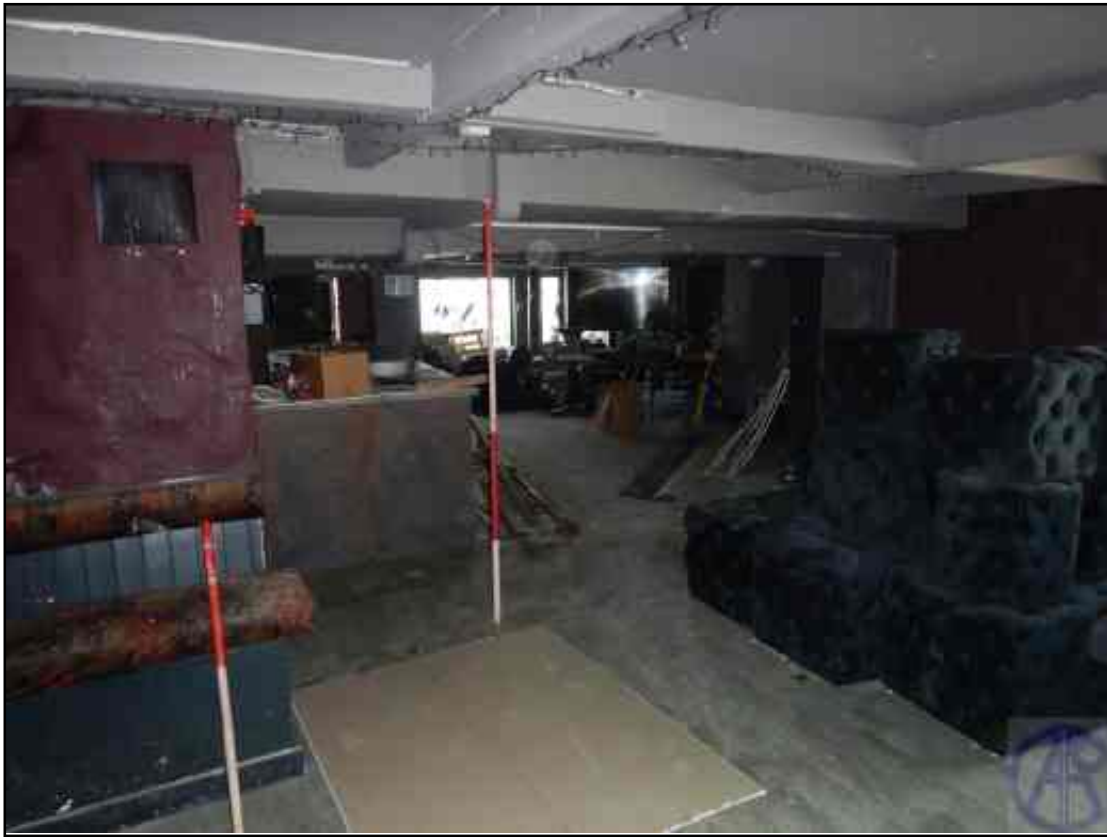
Photo ID: DSCN4412

Room 2, showing the stored materials that restricted access to the walling.

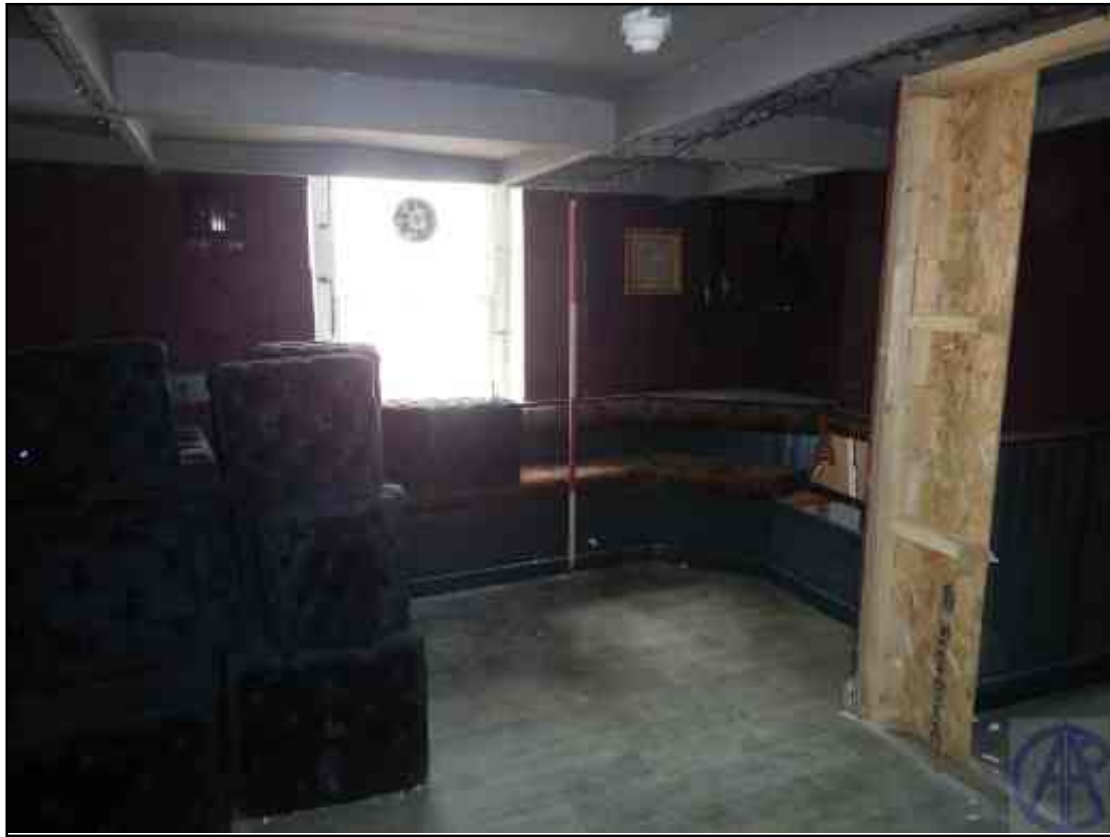
Photo ID: DSCN4409

Timber sash window within the external wall of Room 2..

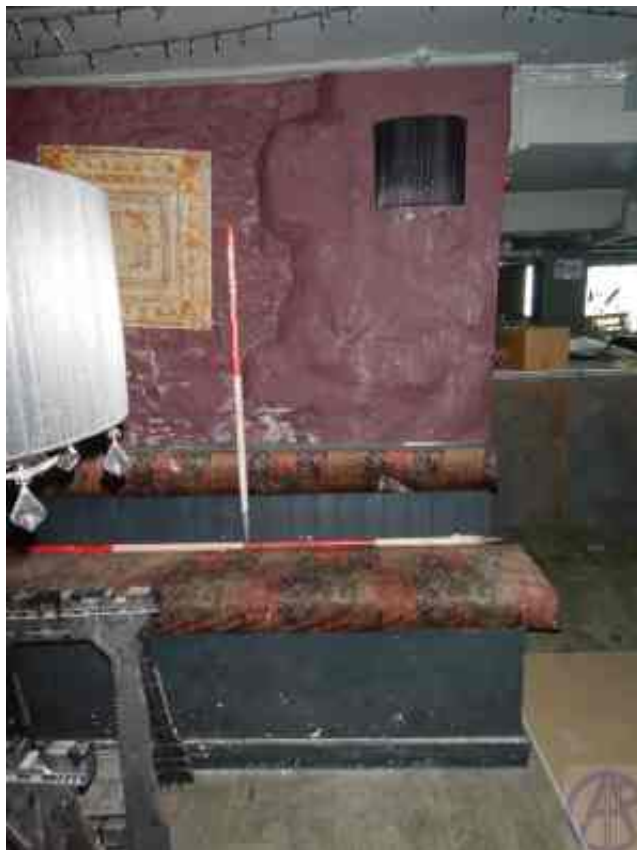
Photo ID: DSCN4405

Broad rendered section at the junction between Rooms 1 and 2.

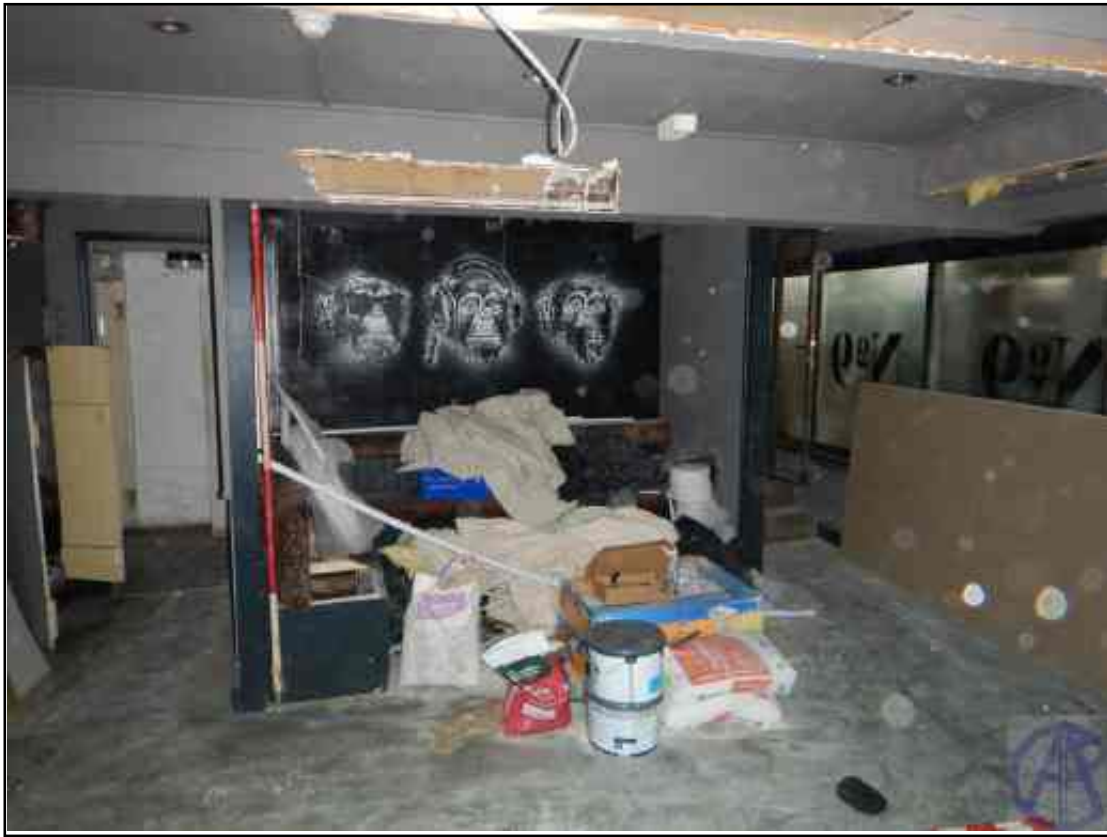
Photo ID: DSCN4440

Area between staircase 6 and the entrance to Room 5

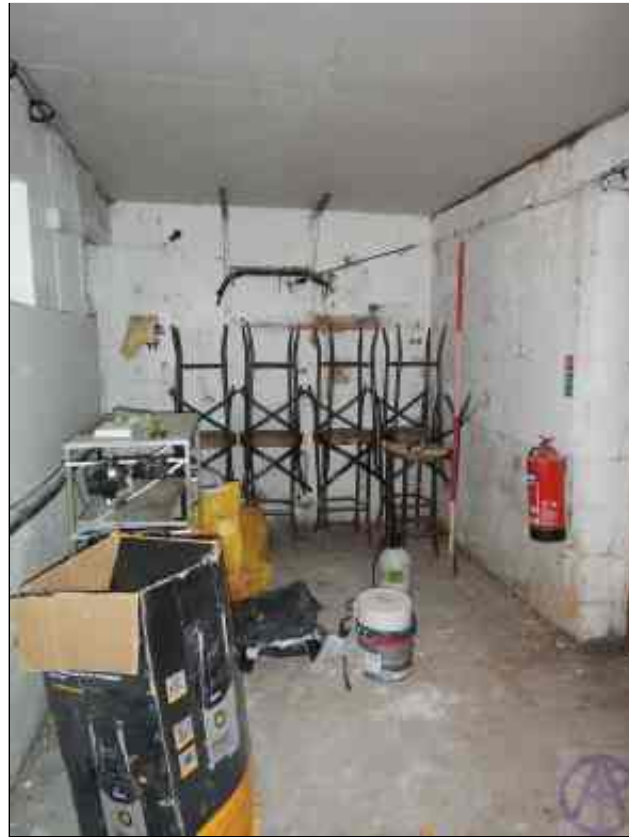
Photo ID: DSCN4426

Room 4, showing the concrete floor, plasterboard ceiling and masonry wall.

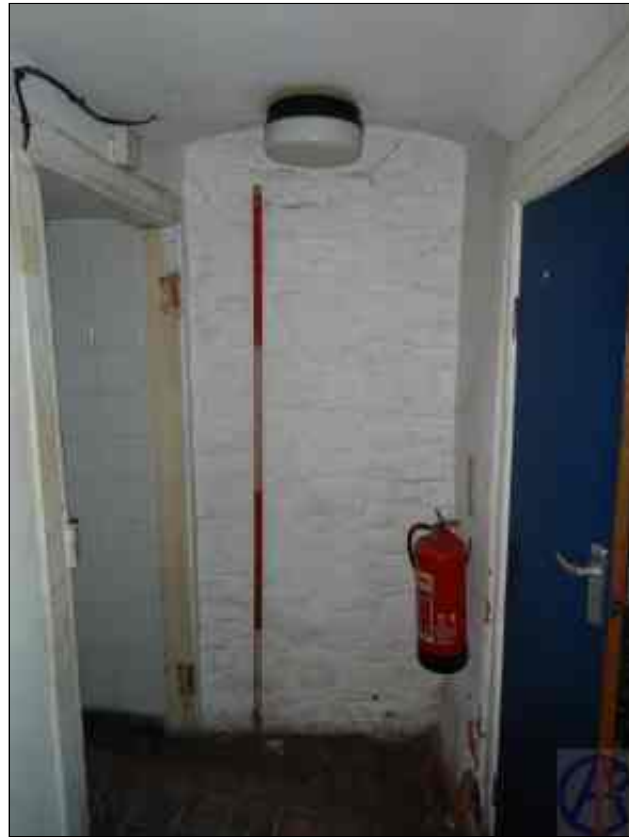
Photo ID: DSCN4431

Passage beneath staircase 6 leading from Room 1 towards Room 5.

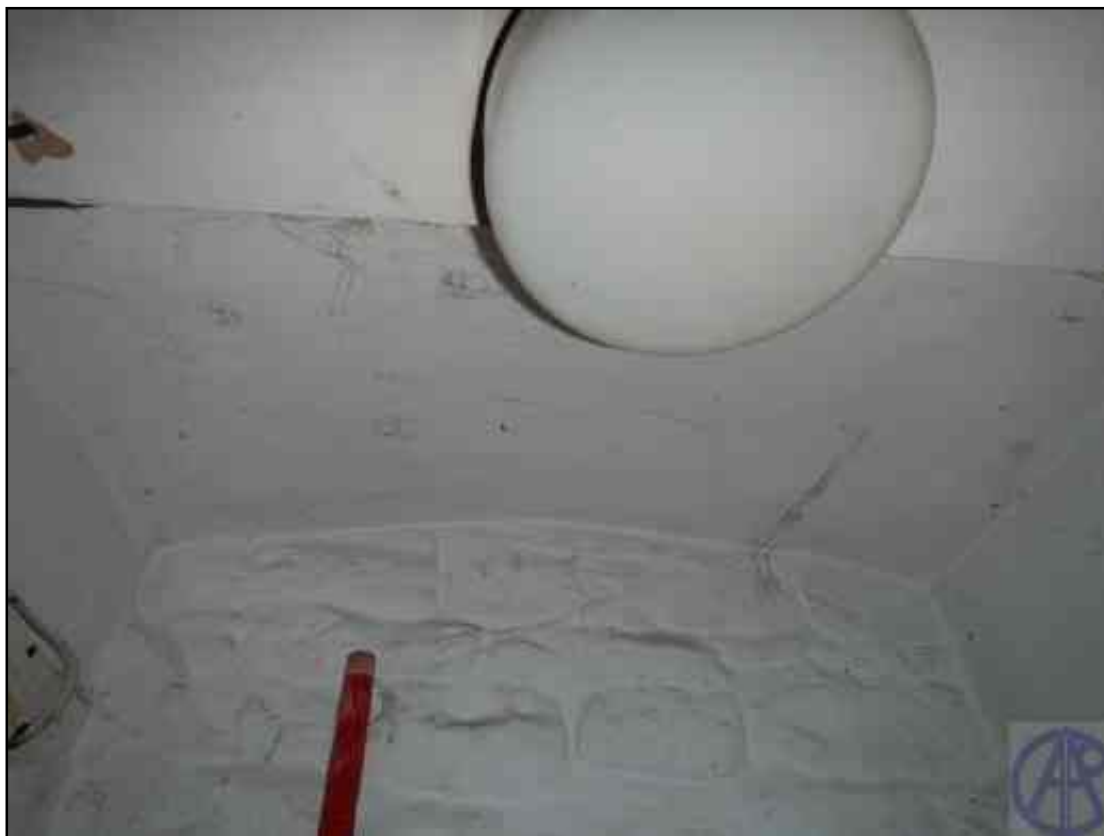
Photo ID: DSCN4432

Curved ceiling profile at the end of the passage  
beside Room 5.

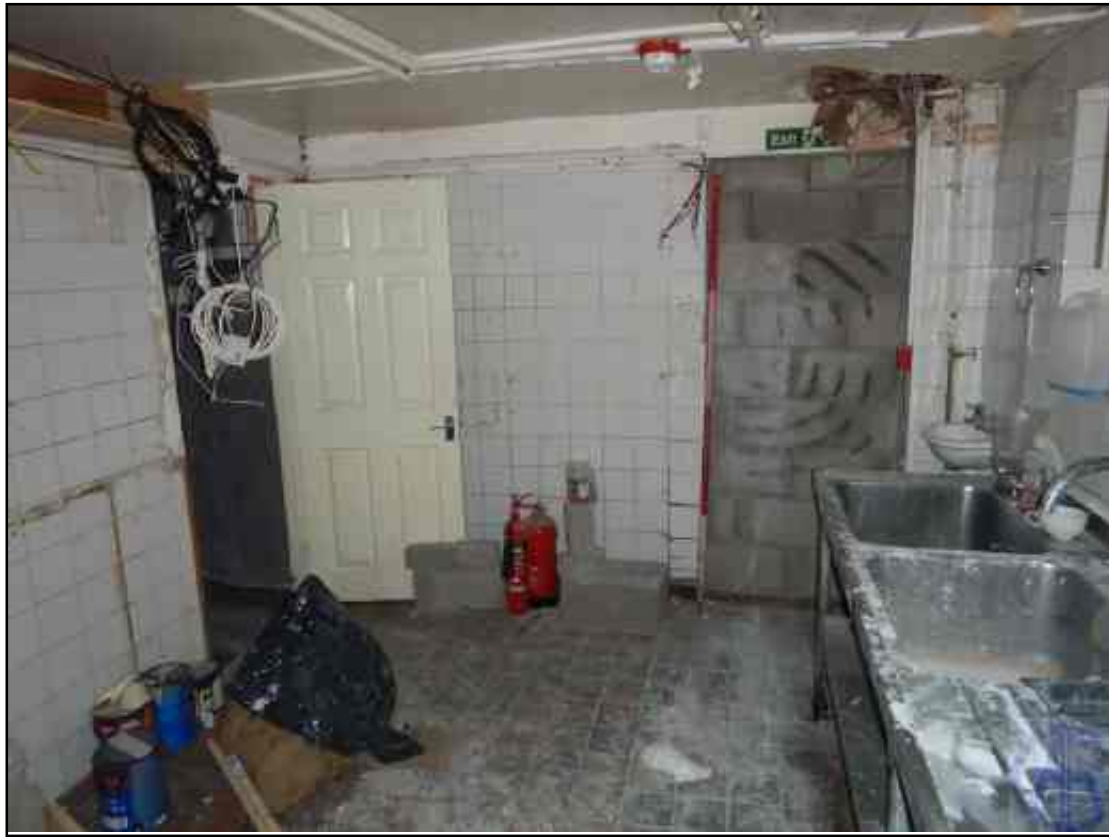
Photo ID: DSCN4437

Quarry-tile floor and modern service fittings within Room 5.

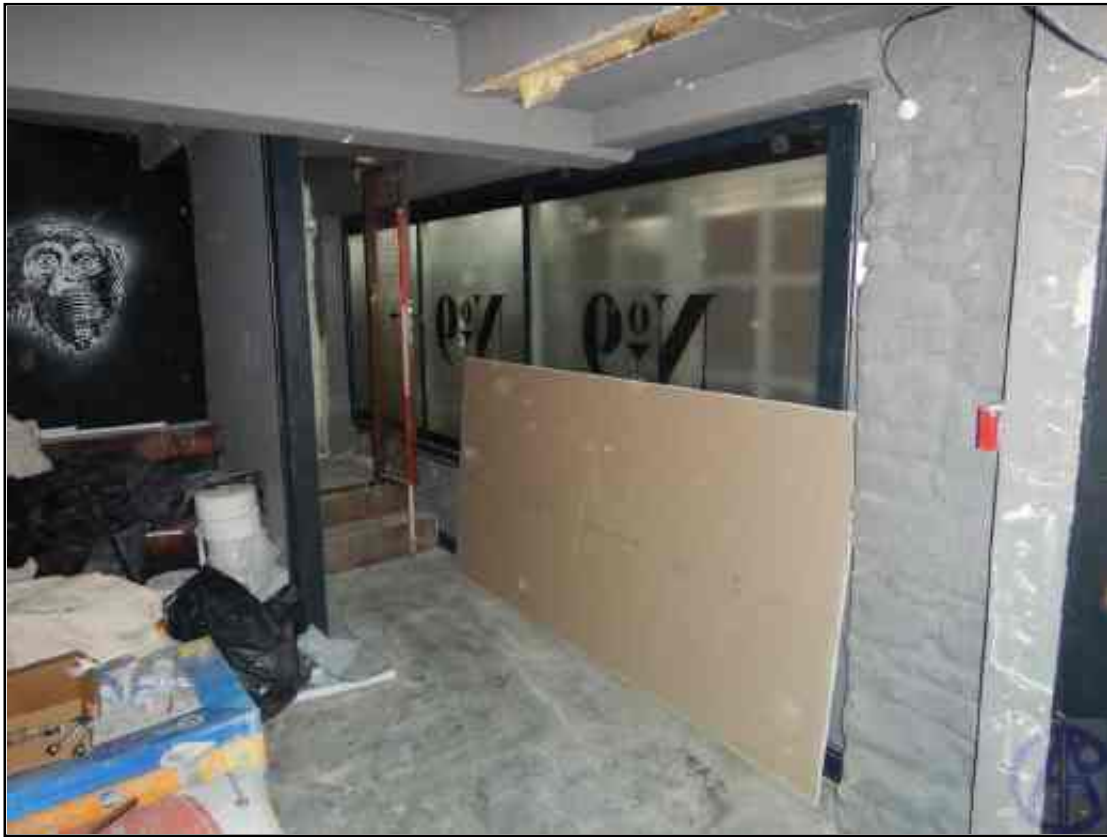
Photo ID: DSCN4441

Ground-floor access to staircase 6 from Room 1.

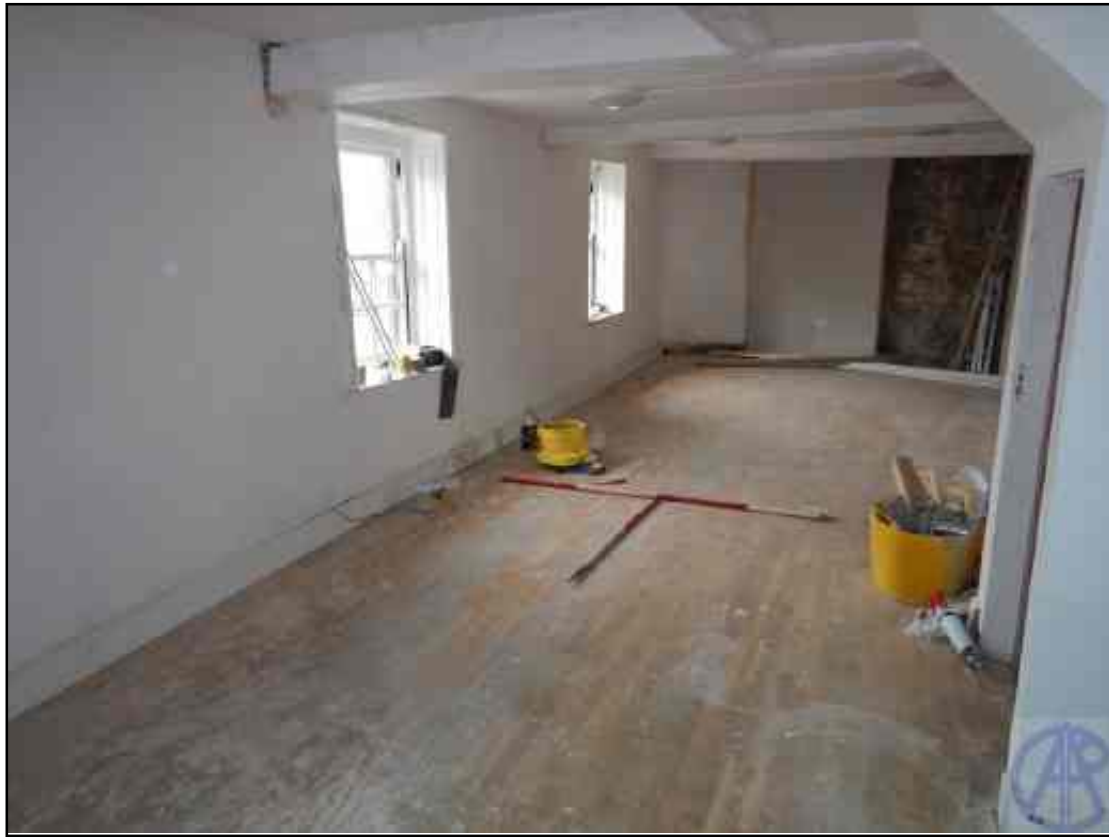
Photo ID: DSCN4449

General view of Room 7 and its exposed structural elements.

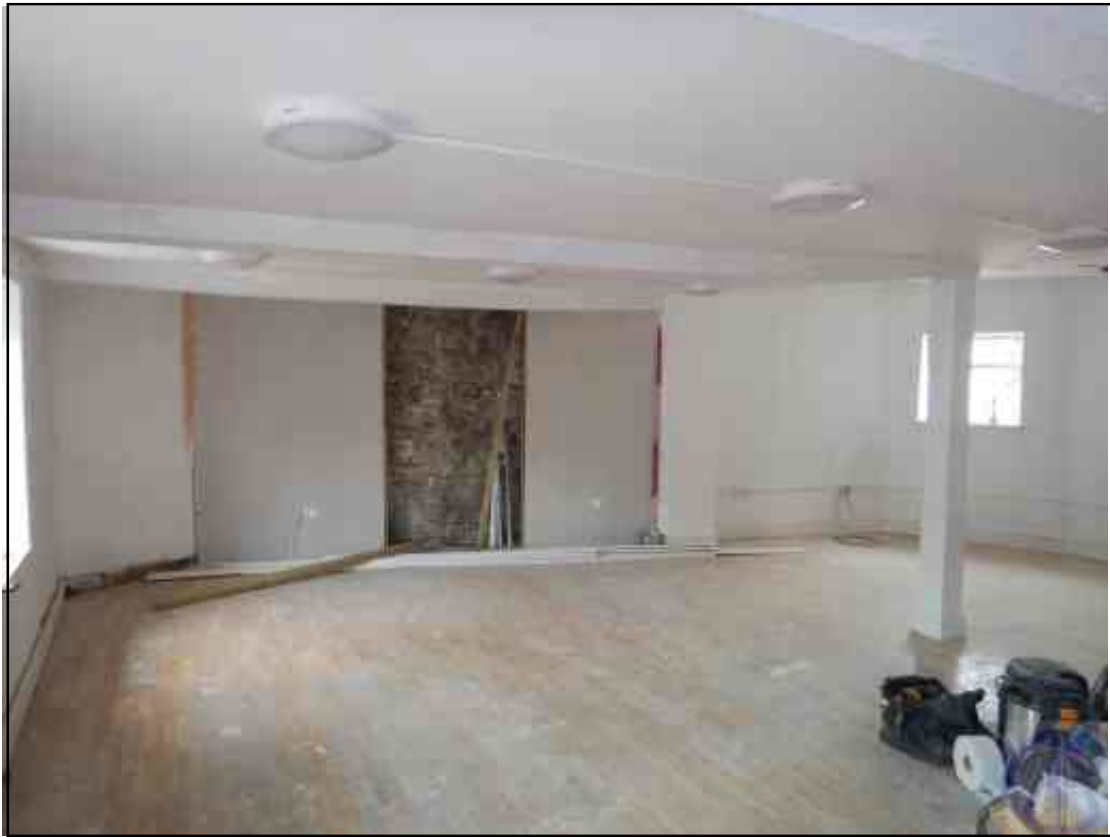
Photo ID: DSCN4462

Room 7, showing the post, central pier and substantial ceiling beams.

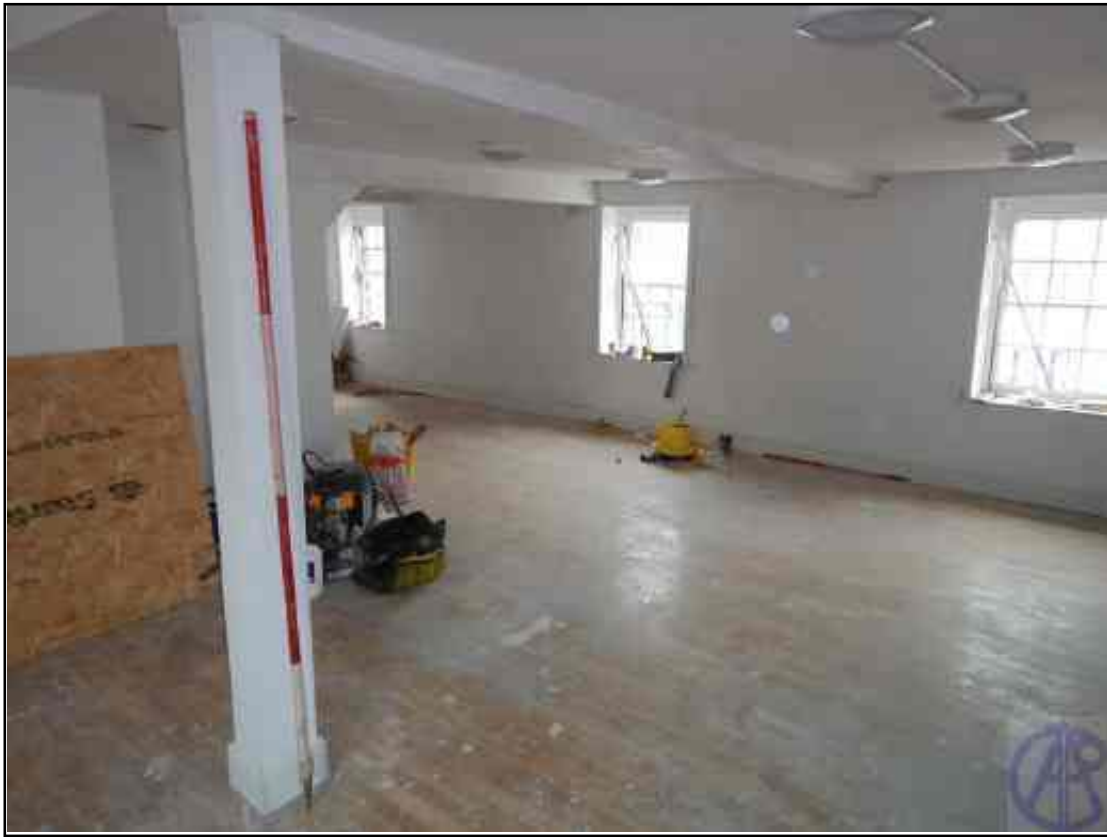
Photo ID: DSCN4466

Substantial irregular-section timber beams crossing Room 7.
